STUDY OF EMBANKMENT PERFORMANCE DURING OVERTOPPING AND THROUGHFLOW

Report 3

MODEL-PROTOTYPE COMPARISON STUDIES

Hon-Yim Ko, R. Jeffrey Dunn, Tom Hollingsworth

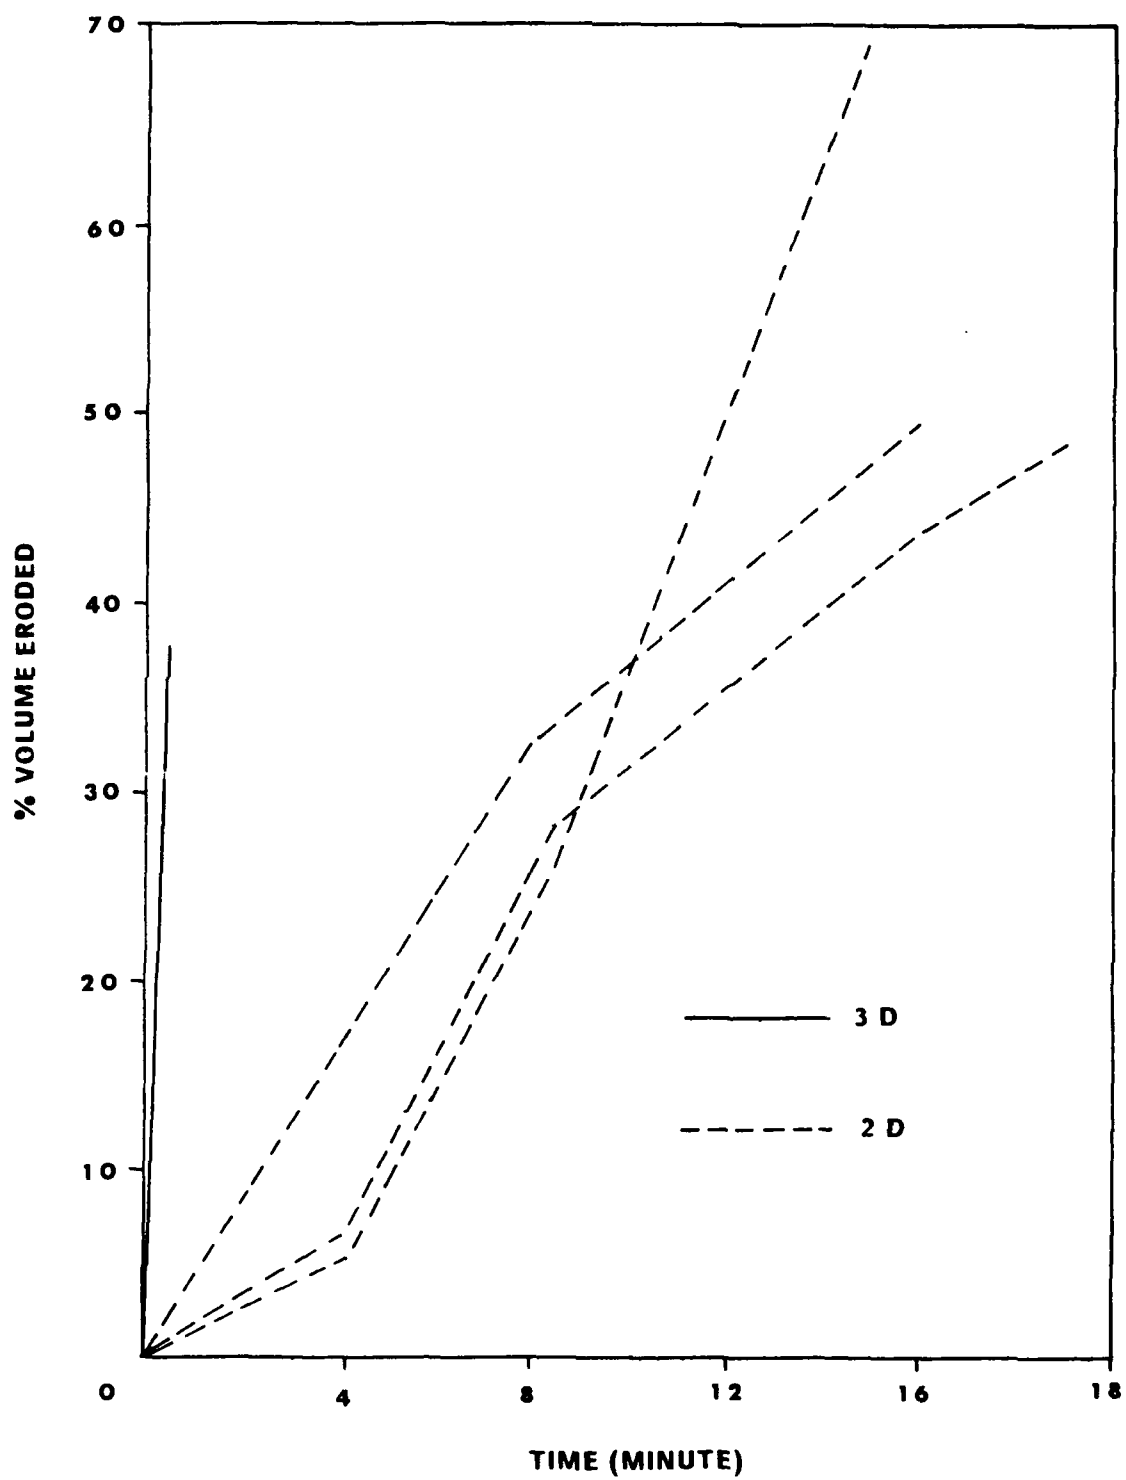
Figure 25 % Volume eroded vs. time SLA embankment. (2D vs. 3D).

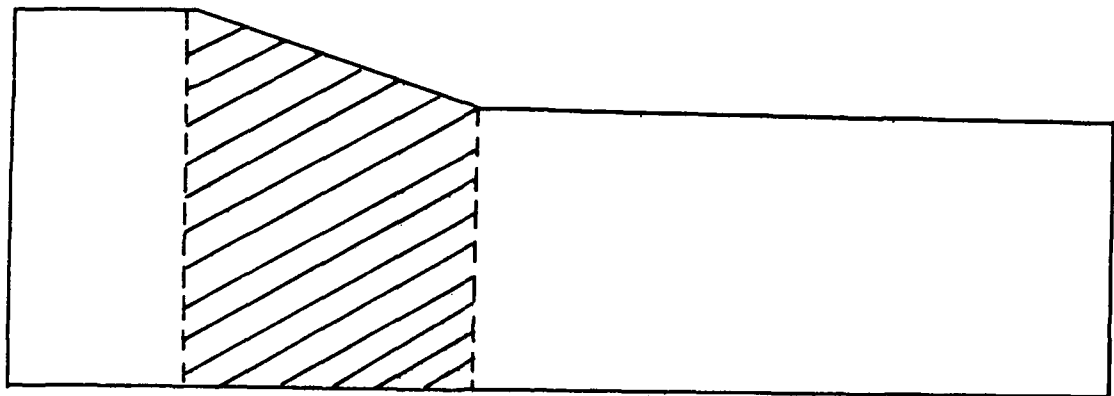
(VOLUME IS EQUAL TO SHADED AREA TIMES EMBANKMENT WIDTH)

Figure 26 Volume available for erosion SLA embankment.

eroded cross-sections was found by a polar planimeter. The volume was then found by averaging the two areas and multiplying by the distance between the cross-sections. The available volume was determined by multiplying the area shown in Figure 26 by 8 inches, the width of the spillway. The calculations of percent volume eroded for the two-dimensional tests were conducted as in Reference [2]. As can be seen from Figure 25, the erosion rates do not compare very well. The three-dimensional rate was much faster than the two-dimensional rate. The accuracy of the three-dimensional volume is questionable. The problem arises from the fact that to determine the eroded volume only two erosion profiles are known. The cross-sections do not encompass the entire slope and linear erosion is assumed between the two sections. Another problem is in defining what the available volume is. These problems lead to questionable accuracy in comparing the three-dimensional and two-dimensional models.

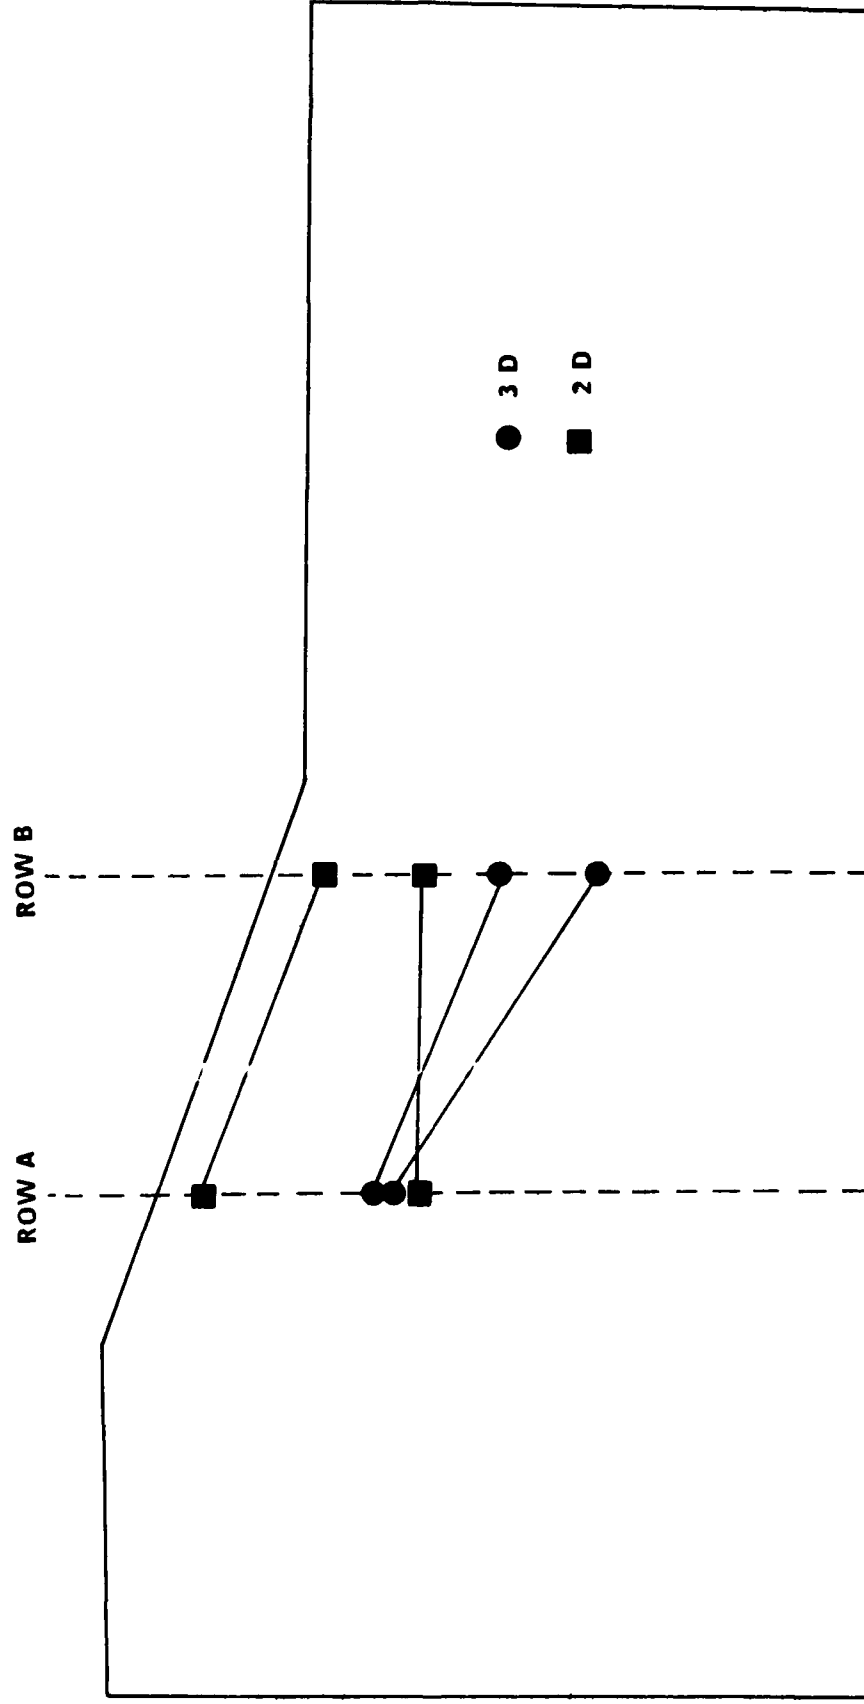
Figure 27 Erosion depth SLA embankment. (2D vs. 3D).

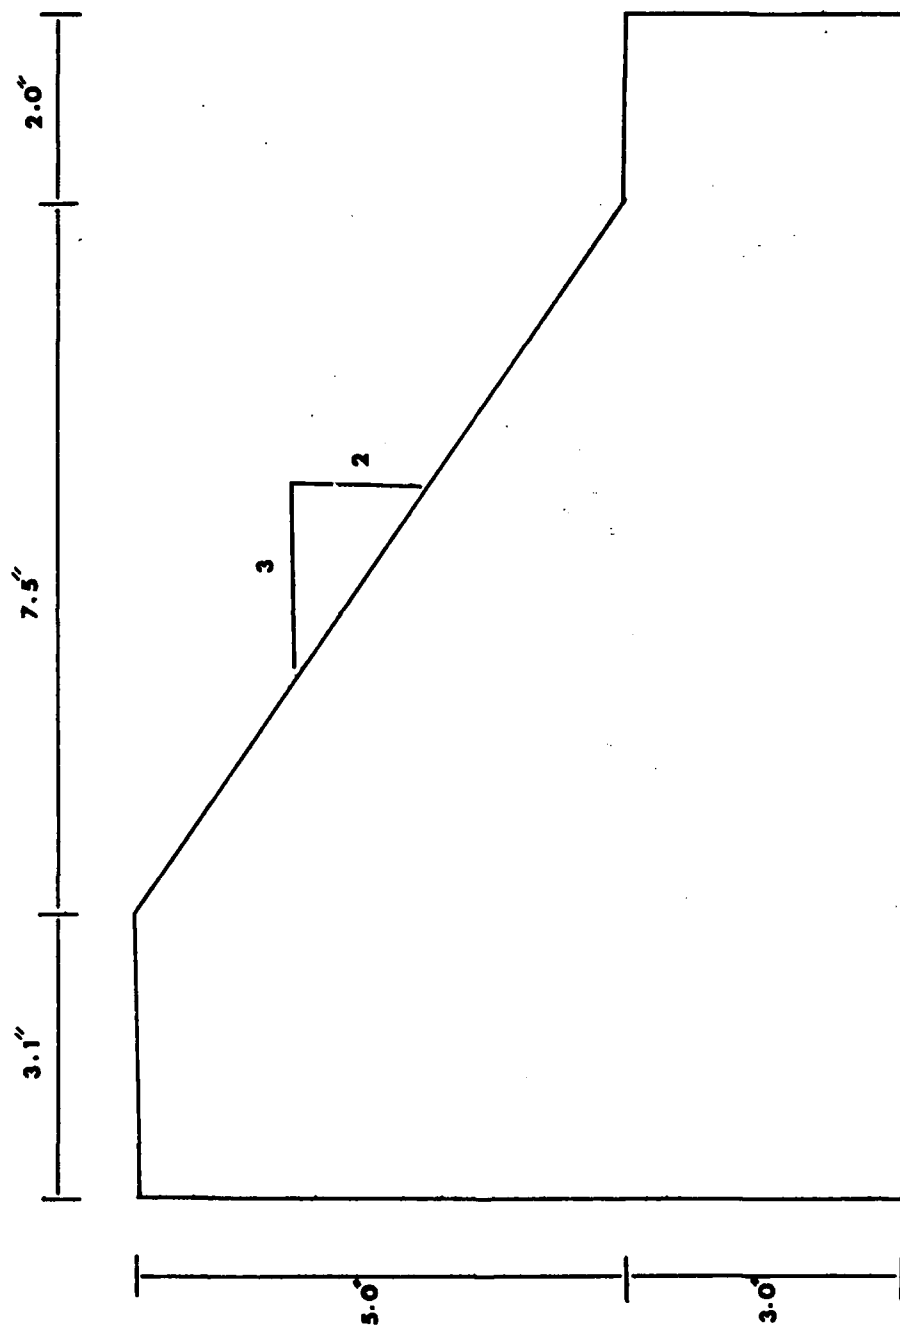
Figure 28 Configuration of crushed rock embankment for feasibility study in 2- dimensions.

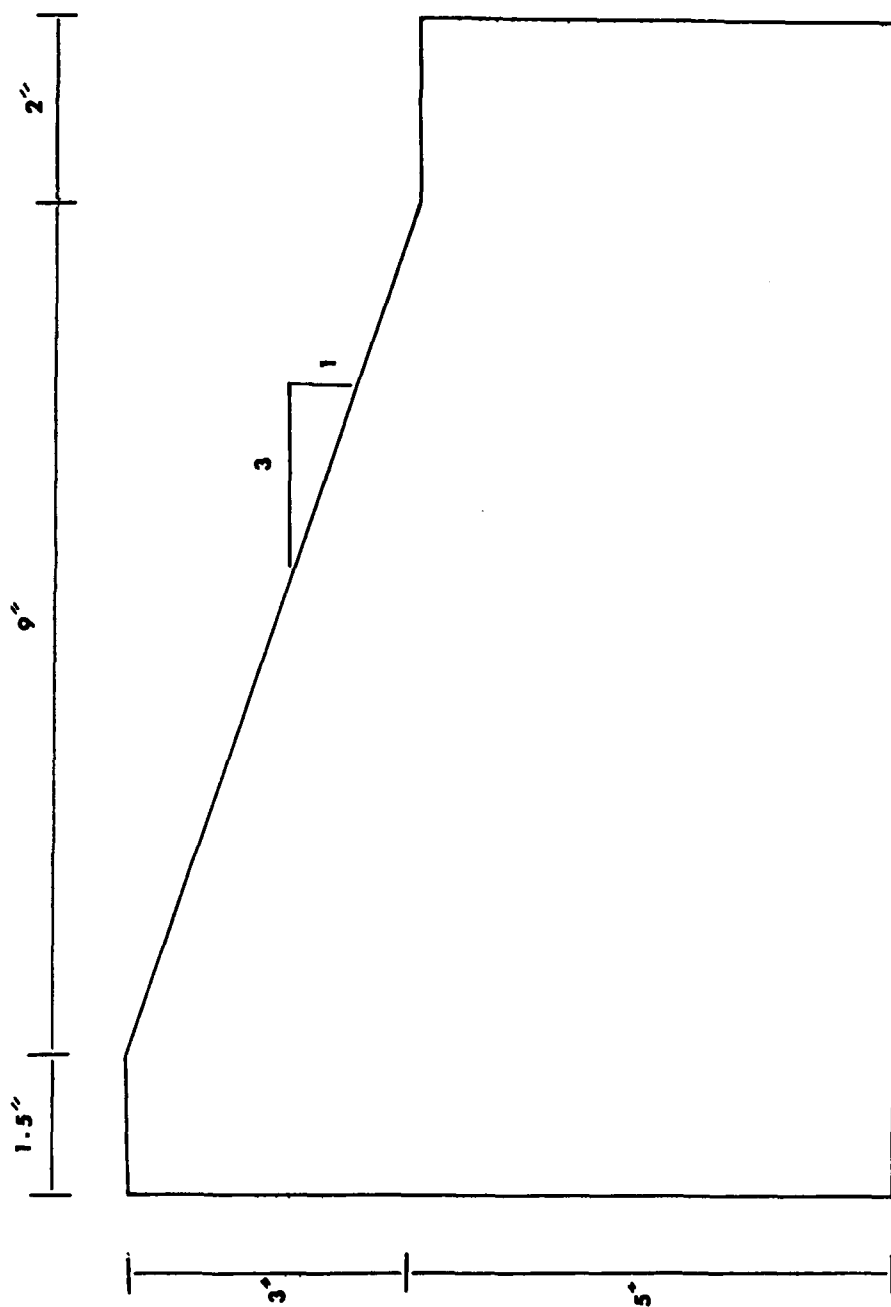
Figure 29 Configuration of clay embankment for feasibility study in 2-dimensions.

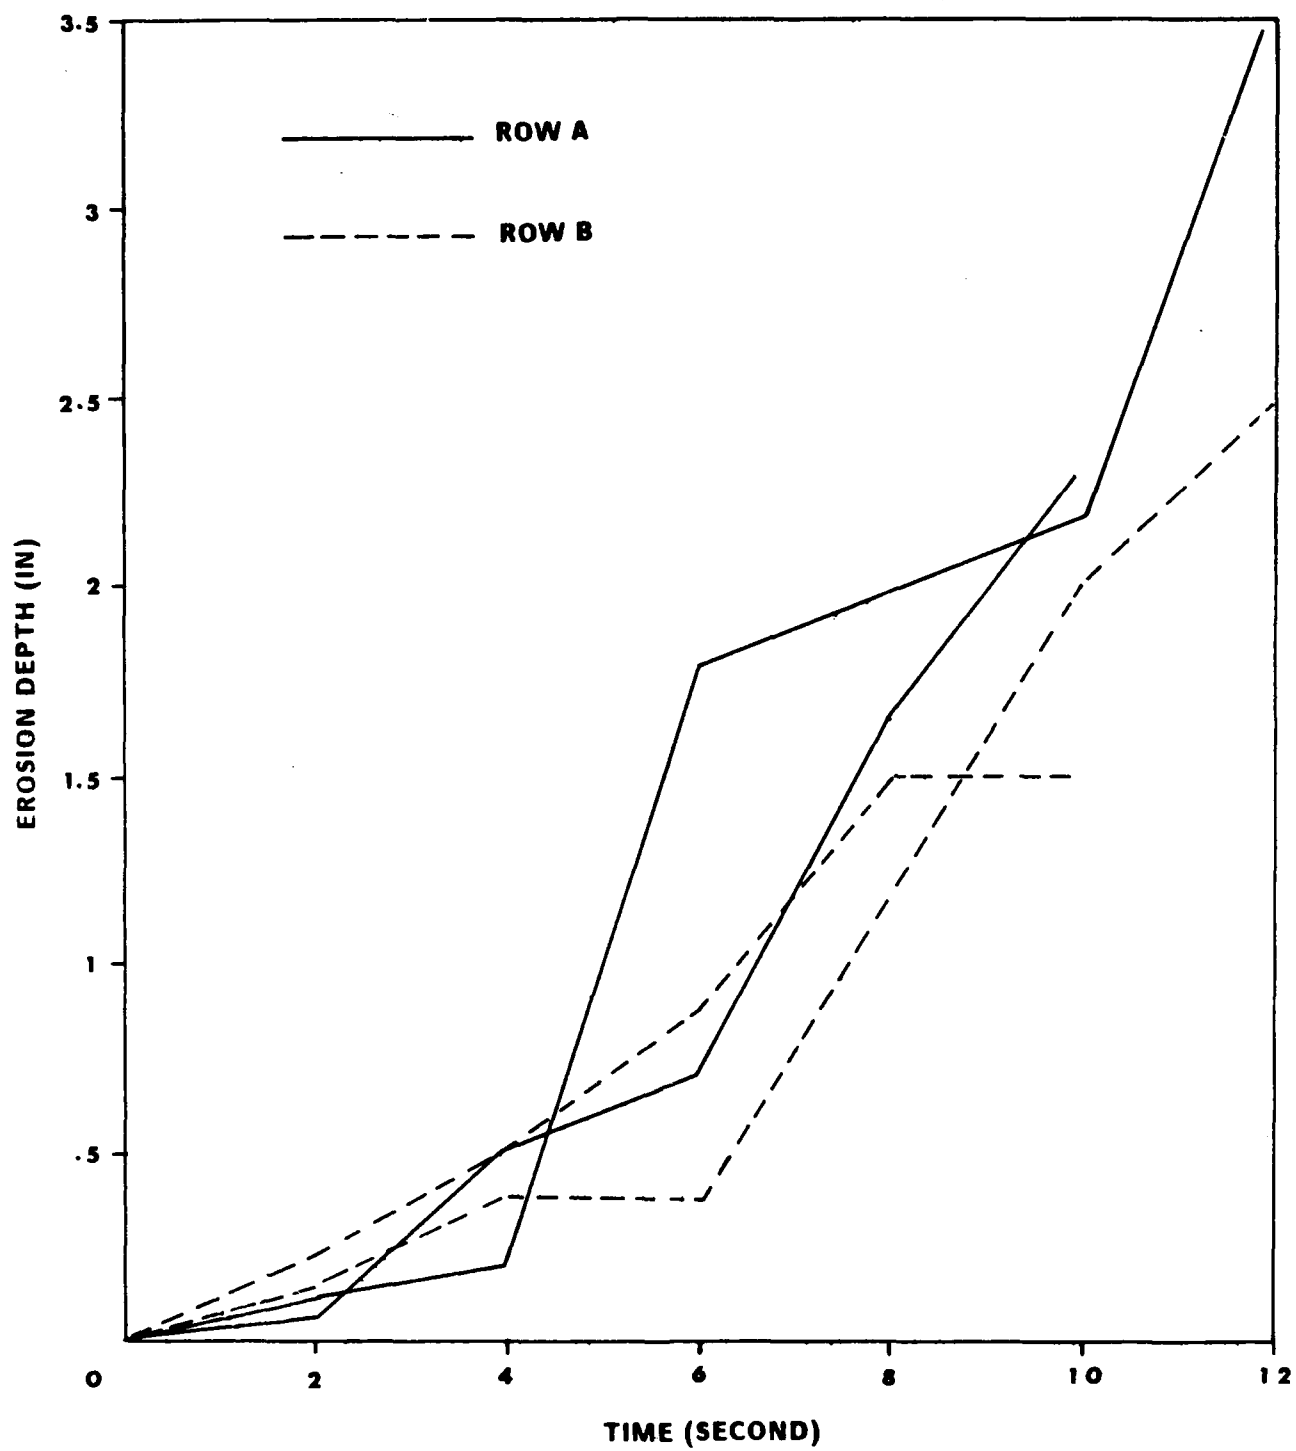
Figure 30 Erosion depth vs. time for crushed rock material.

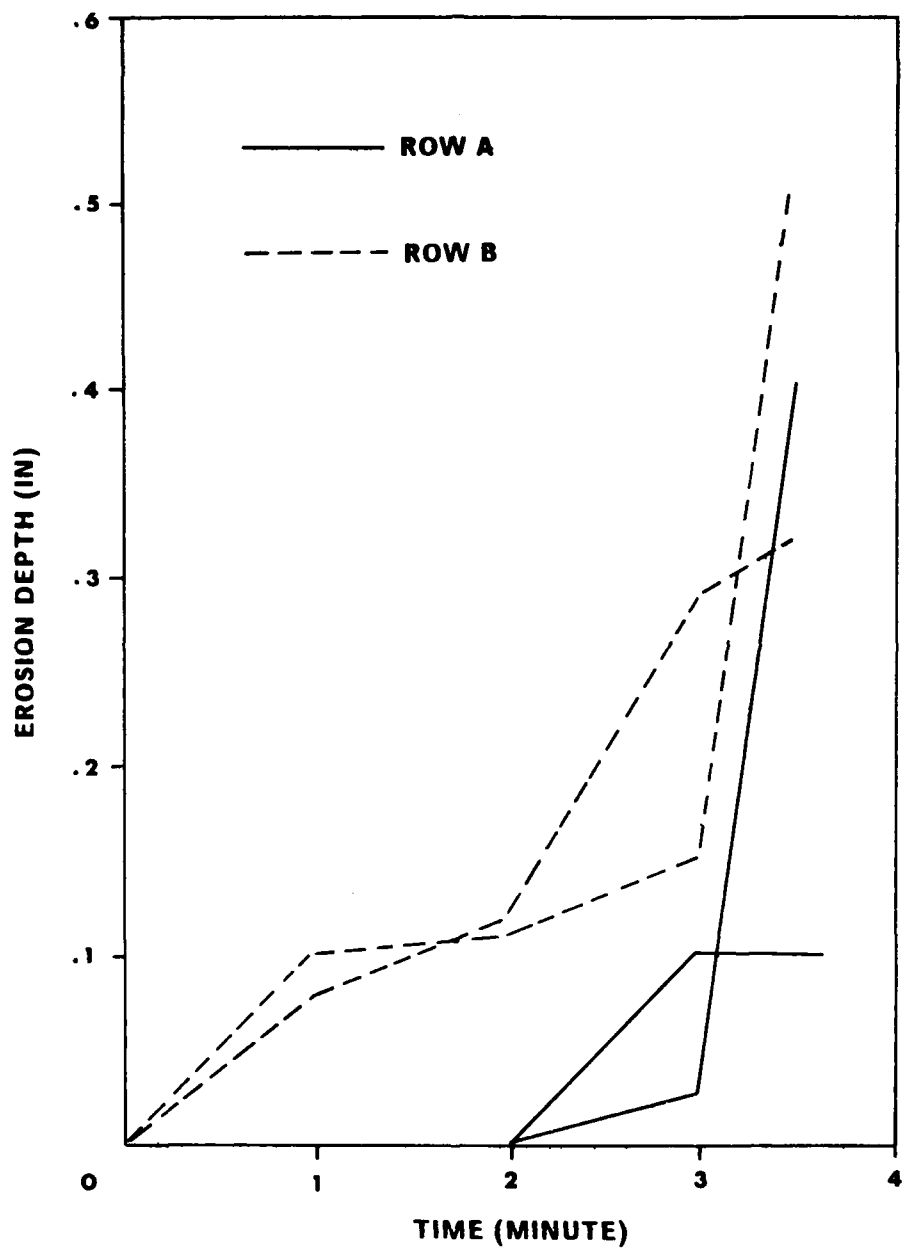
Figure 31 Erosion depth vs. time for clay material.

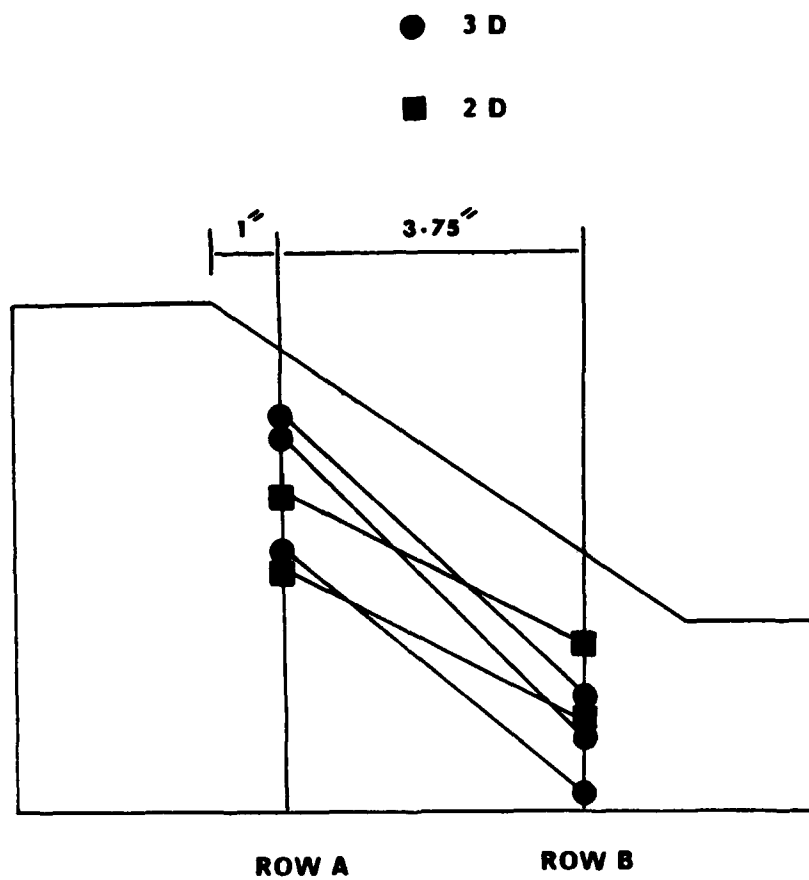
Figure 32 Comparison of the depth of erosion for the 2D and 3D crushed rock embankments.

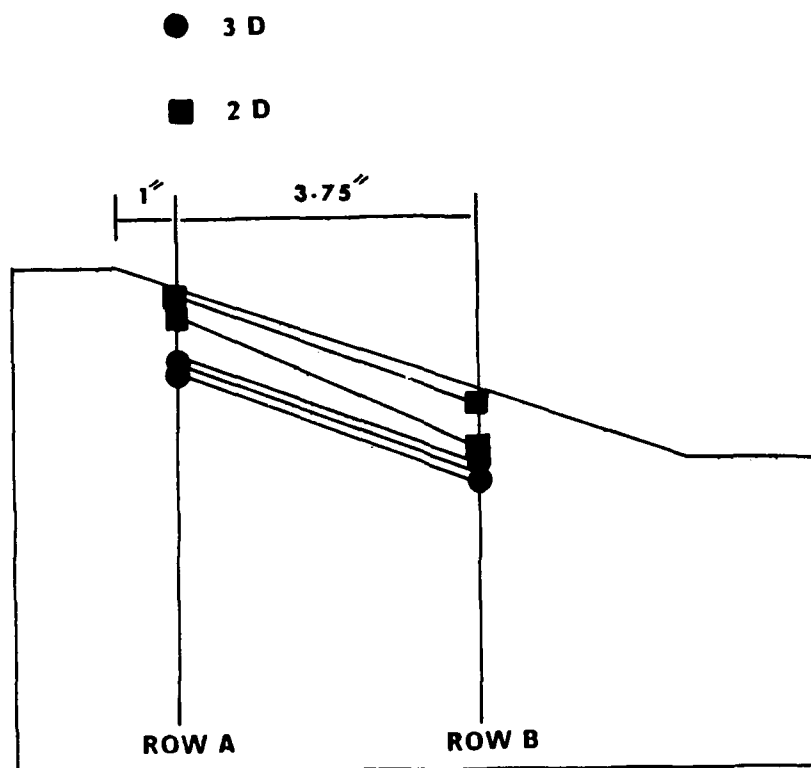
Figure 33 Comparison of the depth of erosion for the 2D and 3D clay embankments.

(49) The three-dimensional and two-dimensional clay embankments eroded at a similar rate and to a similar amount. The depth of erosion also compared very well. Even though the two tests compared favorably, the three-dimensional test method is still recommended, because erosion

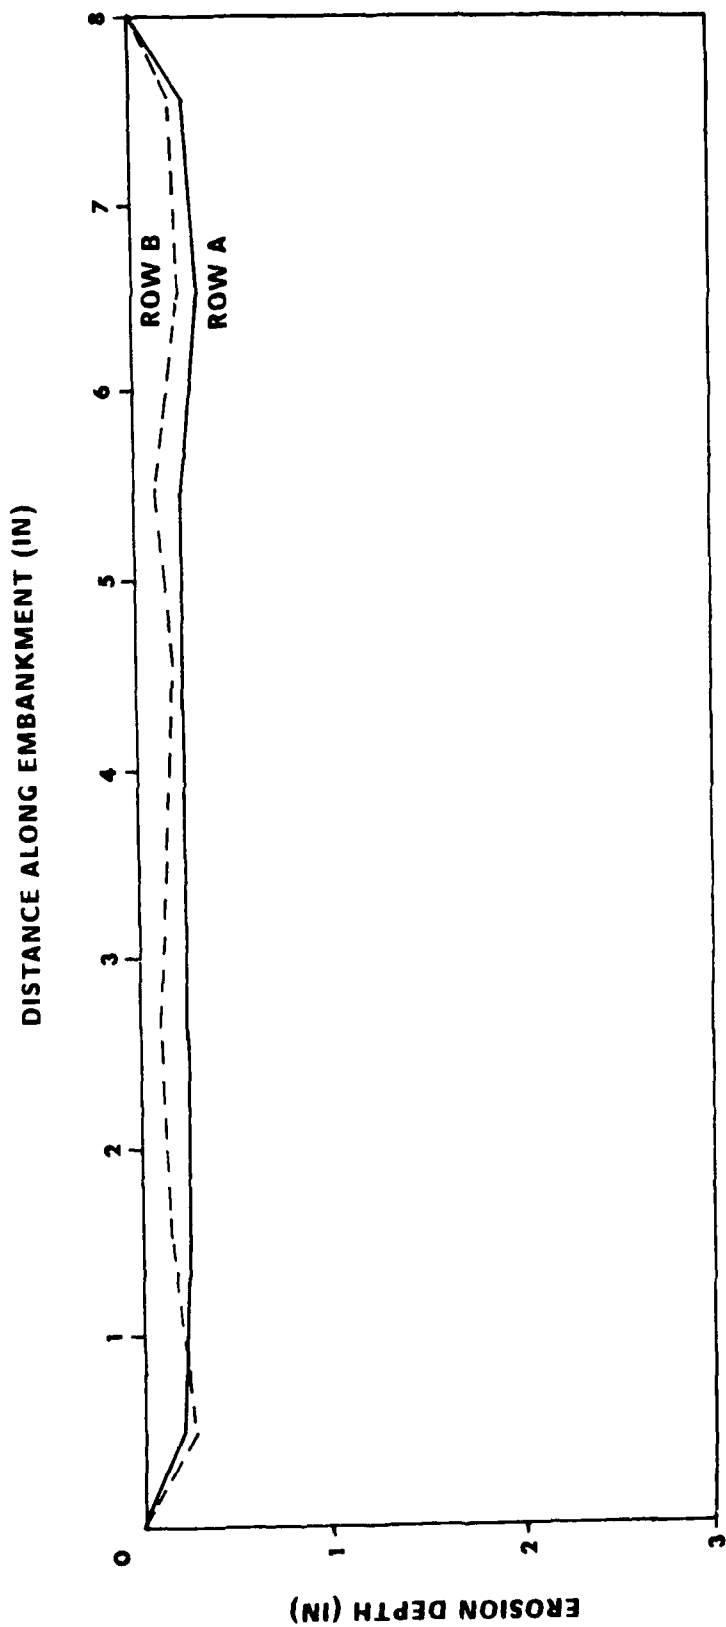
Figure 34a Erosion profile for clay embankment in 3- dimensions.

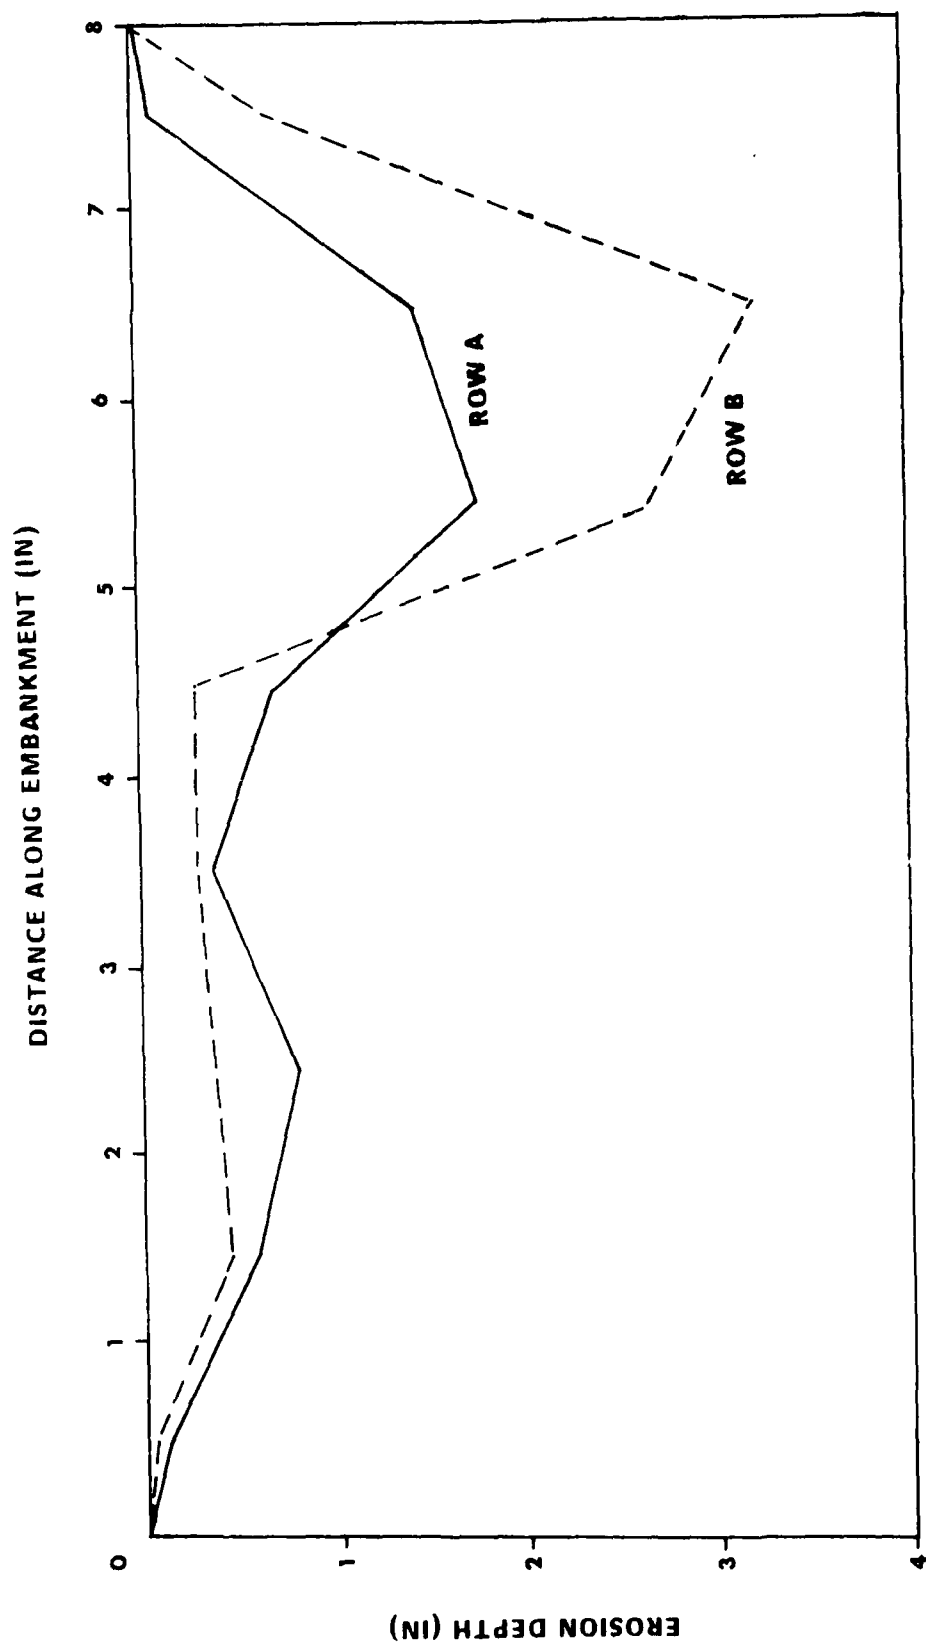
Figure 34b Erosion profile for crushed rock material in 3- dimensions.

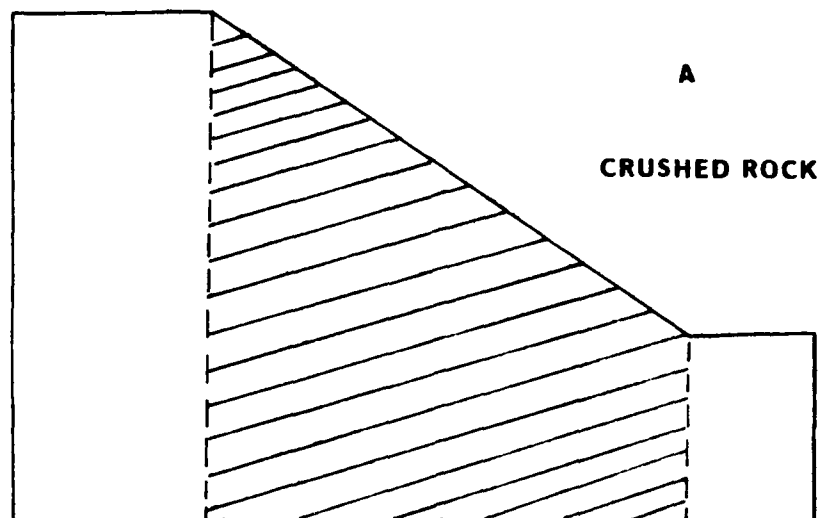
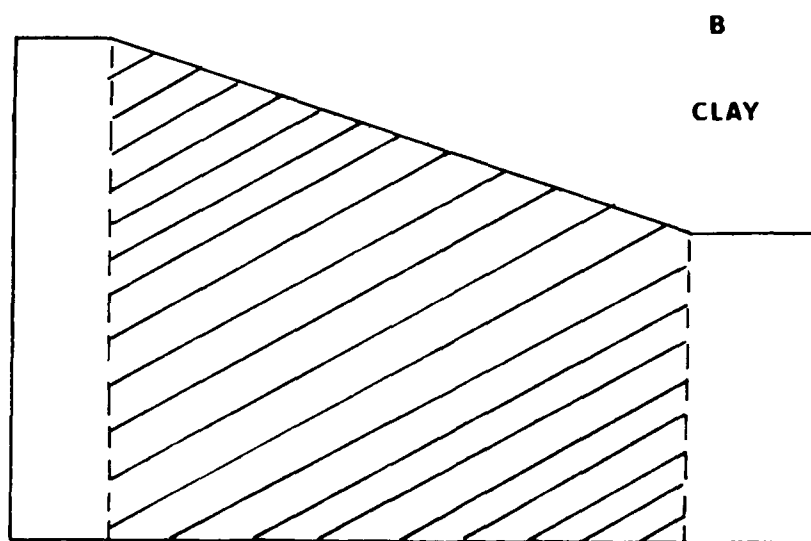
(VOLUME IS EQUAL TO SHADED AREA TIMES SPILLWAY LENGTH)

Figure 35 Volume of material available for erosion in feasibility study in 3 dimensions.

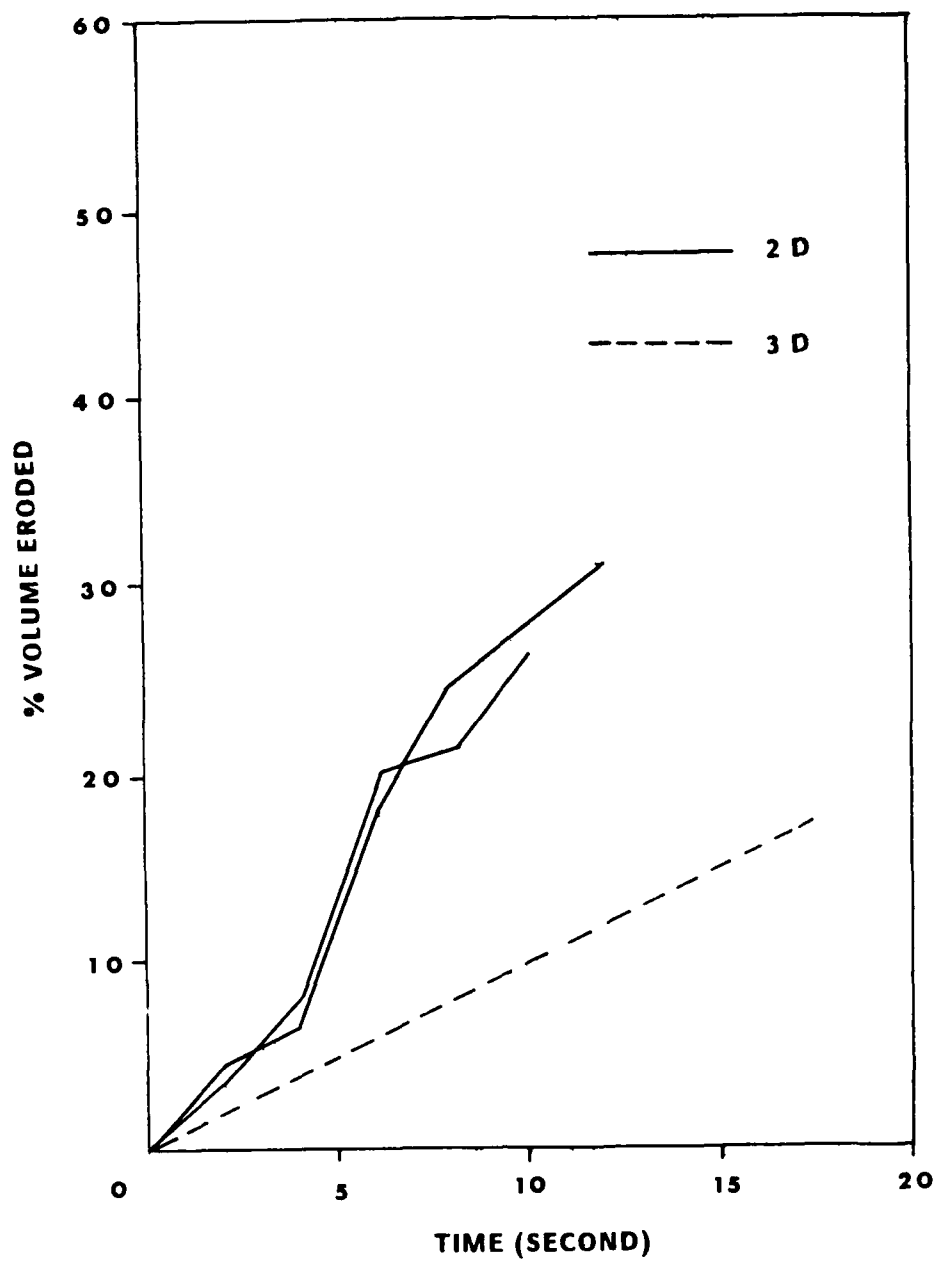
Figure 36 % Volume eroded vs. time for crushed rock material 2D vs. 3D.

(47) The two-dimensional and three-dimensional tests were also compared on a percent of erodable volume basis. In the two-dimensional tests, the percentage of eroded volume was found by using a plane planimeter on the eroded cross-sections to find the eroded area. The eroded area was then multiplied by the thickness of the model to obtain the eroded volume. To obtain the percent volume eroded, the eroded volume was divided by the volume available. The volume available was the areas of the cross-sections shown in Figures 28 and 29 multiplied by the thickness, 0.5 inches. The volume of embankment eroded in the three-dimensional tests was found as previously stated from the cross-sections shown in Figure 34. The volume available for erosion is shown in Figure 35. The percent eroded volume for the two-dimensional and three-dimensional tests is plotted versus time on Figure 36 and Figure 37 for the crushed rock and clay material, respectively.

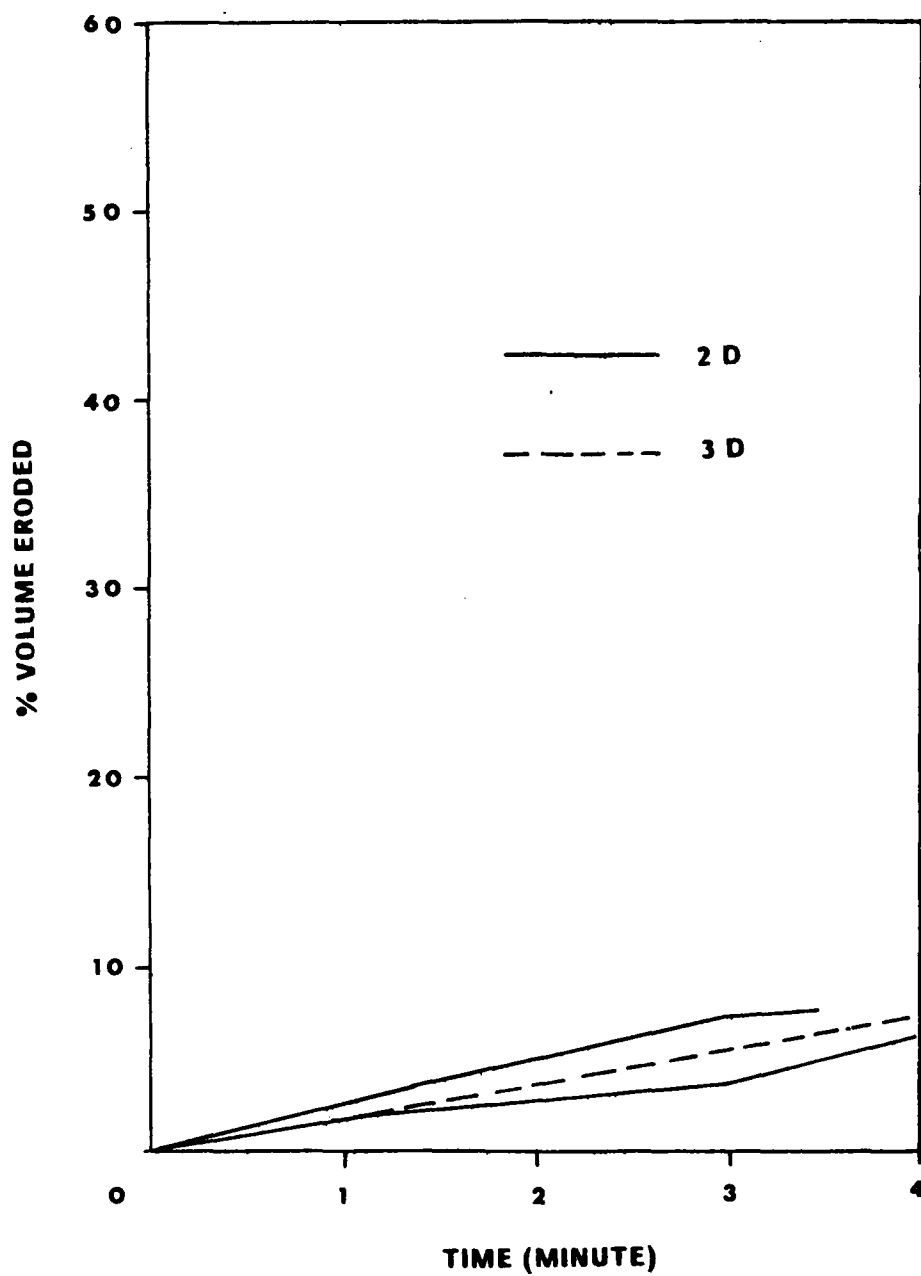
Figure 37 % Volume eroded vs. time for clay material 2D vs. 3D.

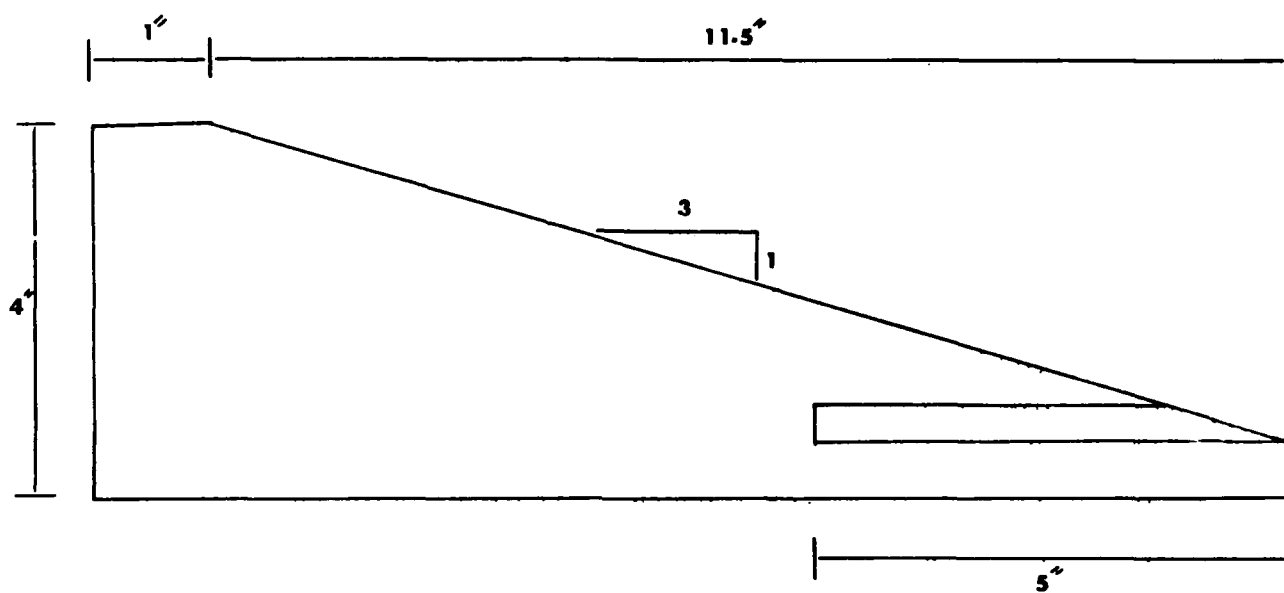
Figure 38 Configuration of major embankment with blanket drain.

(55) As the embankment with a blanket drain was overtopped, erosion started at the toe as expected. The thin layer of Soil 1 that was placed at the face of the blanket drain was quickly removed. Once the blanket drain was exposed, the overtopping water quickly removed the loose blanket drain within 2 to 3 seconds. The removal of the blanket drain left a void with the embankment material standing without any support. This was obviously due to adhesion between the soil and the sample basket

(57) The addition of a sand drain to the embankment cross-section caused the embankment to fail sooner than a homogeneous embankment. The cohesionless drain material eroded quickly and undercut the embankment causing failure. In a prototype embankment, similar results could be expected.

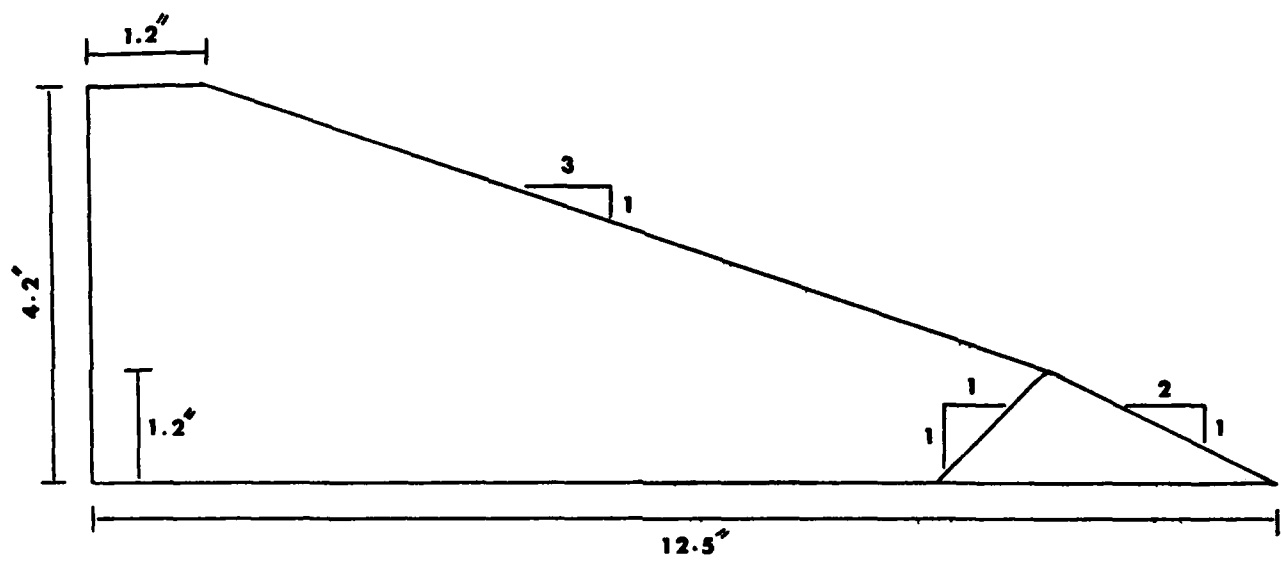
Figure 39 Configuration of major embankment with rock toe.

(56) The embankment with the rock toe behaved in a similar manner as the embankment with the blanket drain. As the embankment was overtopped, the thin layer of soil placed on the face of the rock toe was immediately removed. Once the soil layer was gone, the rock toe was washed out almost instantly. The rock toe was removed in the first few seconds of overtopping. With the removal of the rock toe, the embankment eroded in the typical manner, erosion starting at the toe and working up the embankment. It took 23 seconds for the embankment to fail.

(58) The addition of the rock toe to the embankment cross-section also caused failure to occur more rapidly than a homogeneous embankment. The rock toe failed quickly, thus causing failure of the embankment. A prototype embankment would react similarly if the composition of the rock toe was comparable to the scaled version that was tested.

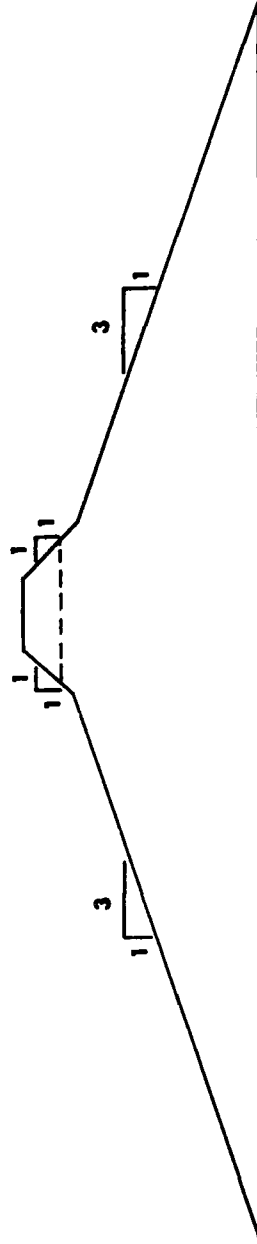
Figure A.1. Cross section of Clarence Cannon Cofferdam scale: 1 in. = 300 ft.

(4) Damage. Overtopping flow was primarily contained in the notch area, with breaching in the center of the notch occurring after 20 hours of overtopping. Maximum depth was reached about this time. Limited flow over other areas of the cofferdam occurred after a few hours prior to notch breaching. The partially complete earth embankment, with very shallow slopes, allowed spread of the flow over a crest length of 850 ft. Apparently, the main embankment sustained very little damage until about 8 hours after notch breaching. At this time erosion reached the horizontal drainage blanket at the downstream main embankment toe and started removing the granular blanket materials from beneath the central portion of the downstream slope. This undercutting of the overlying cohesive fill by removal of the draining blanket continued for 8 to 10 hours until the chimney drain was reached. The chimney drain was removed from the left abutment to the concrete dam section without appreciable damage to the upstream portion of the main embankment. The chimney drain and 30 to 40 percent of the downstream embankment fill were lost.

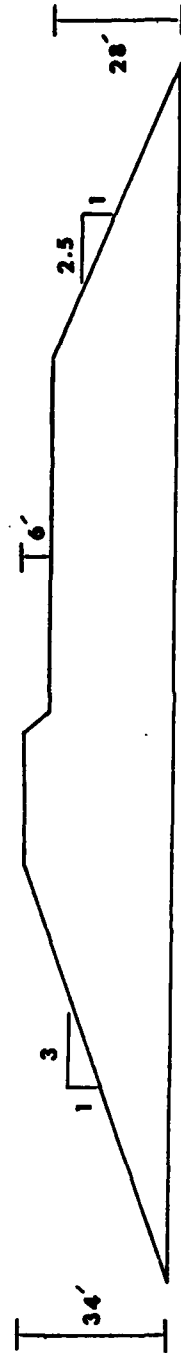
Figure A.2. Cross section of Bloomington Lake Cofferdam.

(8) Damage. Flood waters overtopped the dike for about 25 minutes before the cofferdam was overtopped. After 4 hours of overtopping, erosion began adjacent to the right abutment which was lower than the rest of the embankment. The erosion continued through the cofferdam until full breaching occurred approximately 10 hours after overtopping started. The breach was 70 ft. wide and eroded to foundation level with vertical faces. The remaining portion of the embankment's downstream slopes had vertical faces 15 to 20 ft. high. Breaching of the diversion dike followed cofferdam breaching by 10 minutes.

(9) Breaching, which occurred at the lower part of the embankment and at the more abrupt abutment, took 4 hours to start and 10 hours to complete. The relatively long crest (100 ft +) increased breaching time. The more easily eroded rock toe probably accelerated undercutting of the downstream slope and subsequent breaching. The random earth, fine-grained compacted embankment should have withstood breaching longer, especially with such a long crest length. Other factors could have been concentration of flow at the right abutment and poor rock abutment-fill contact. Loss of tailwater and saturation probably prompted quick breaching of the upstream dike after cofferdam breaching. If the left portion of the embankment had been lower and received the major portion of flow, breaching might have been delayed further because of the shallow sloped left abutment. This would have provided a large earth mass for erosion.
